## Lower Left First Molar Case Study

### Radiographs

Originally printed in the European Journal for Dental Implantologists, Vol 13, Issue 2/2017

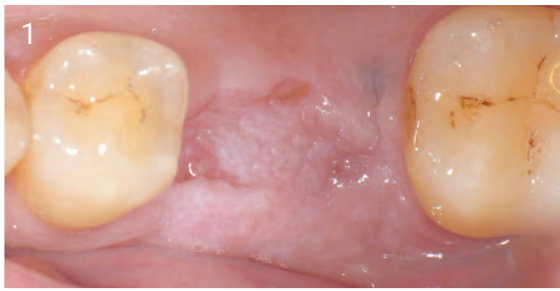
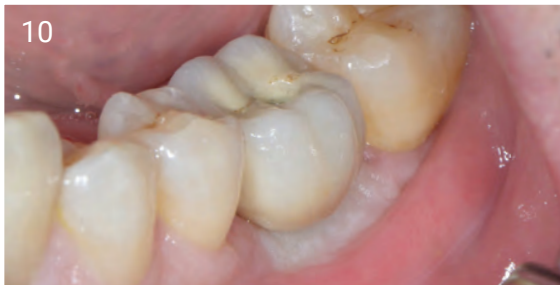
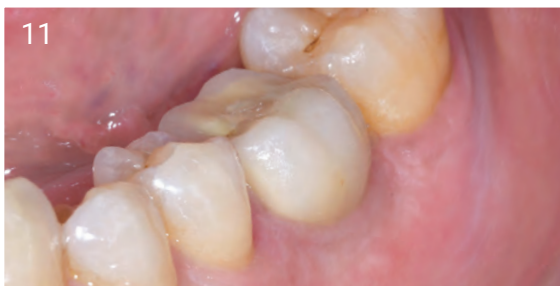
1. Clinical view four weeks after extraction.
2. Clinical view after extraction of the root and thorough debridement of the site.
3. Implant placed at the correct 3D positioning. Note the bone defect between the implant surface and the surrounding bone walls.
4. Bone grafting with ethoss®.
5. Tension free closure.
6. Clinical view after 10 weeks.
7. ISQ measurement showing high secondary implant stability.
8. Occlusal view after placing of the healing abutment.
9. Maturation of the soft tissues 2 weeks after placement of the healing abutment.
10. Screw-retained metal-ceramic crown fitted and torqued at 35Ncm.
11. Clinical view one year after loading of the implant.
