PERIODONTAL GRAFTING

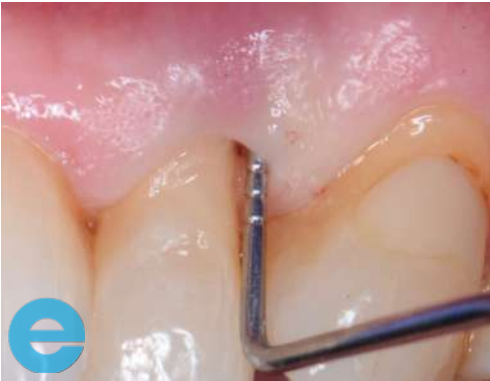
1. Probing showed a 8mm distal pocket

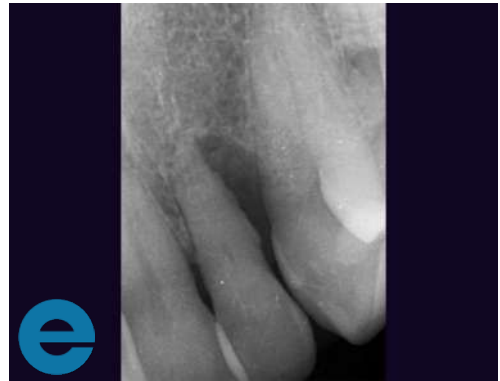
2. Radiograph shows large distal bone loss to the apex of the tooth, which is grade 3 mobile

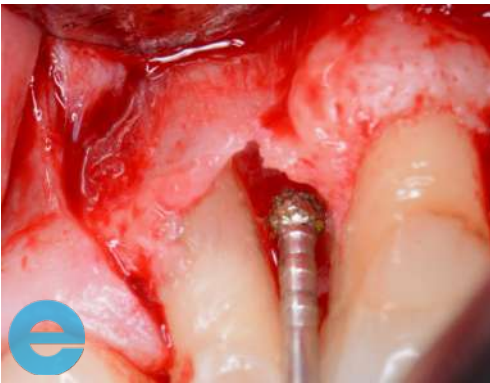
3. Flap is raised and bone defect was cleaned with EthOss® Degranulation Burs

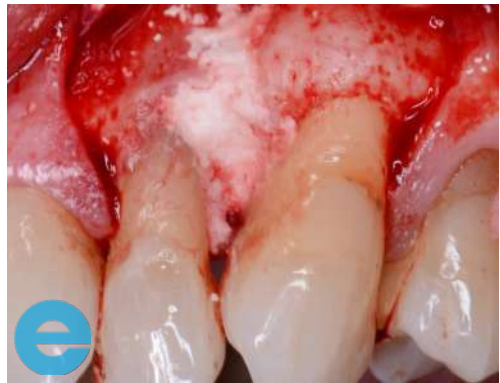
4. Site grafted with EthOss bone grafting material

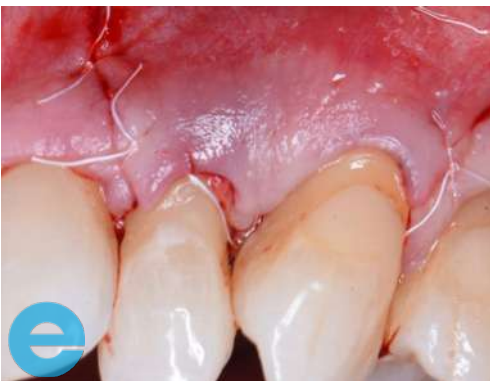
5. Flap is sutured closed

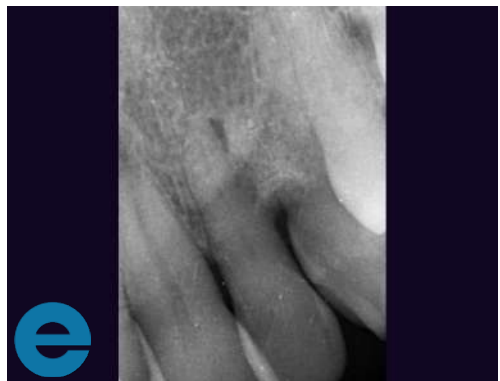
6. Radiograph showing site now grafted with EthOss bone grafting material

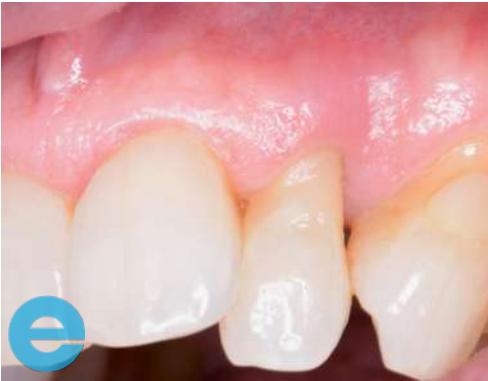
7. Loaded at 4 months - very solid but consideration around whether a better flap design could have improved soft tissue

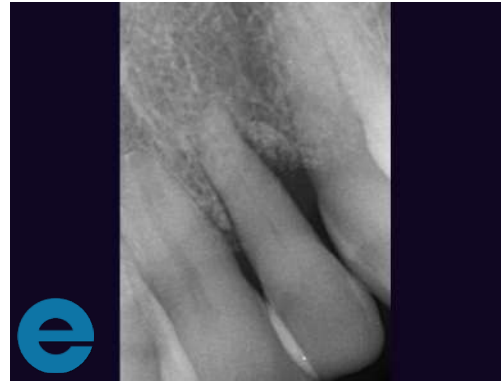
8. Loaded at 4 months - radiograph showing new bone regeneration
